### NextGen Boiler – Stuck impeller on Wilo Circulator

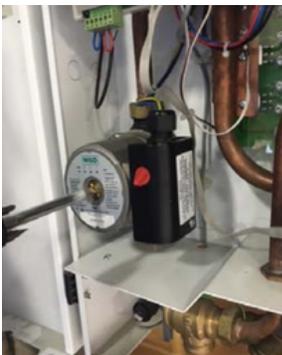
Figure 1

**Step 2-** Use a slotted screwdriver to remove the brass vent plug located in the center of the Wilo circulator. (Fig. 1) Note that you will observe a small amount of water coming out of the circulator.

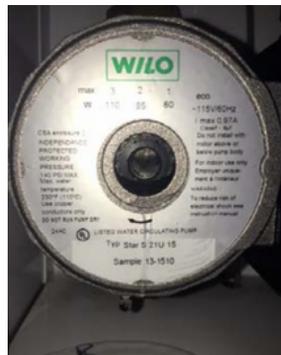
Figure 2

**Step 3-** Locate the impeller with the screwdriver slot within the interior portion of the pump. (Fig. 2)

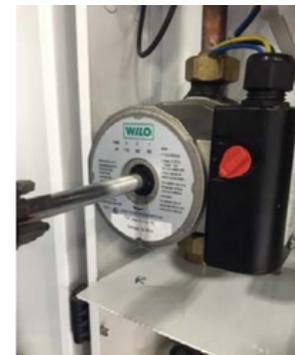
Figure 3

**Step 4-** Use a slotted screwdriver to turn the impeller a couple of revolutions. (Fig. 3)  
Replace vent plug.
